20 February 2020

BUILDING CONDITION ASSESSMENT REPORT

Subject Property: 16 Harbour View Road
Tahawai
Katikati 3170

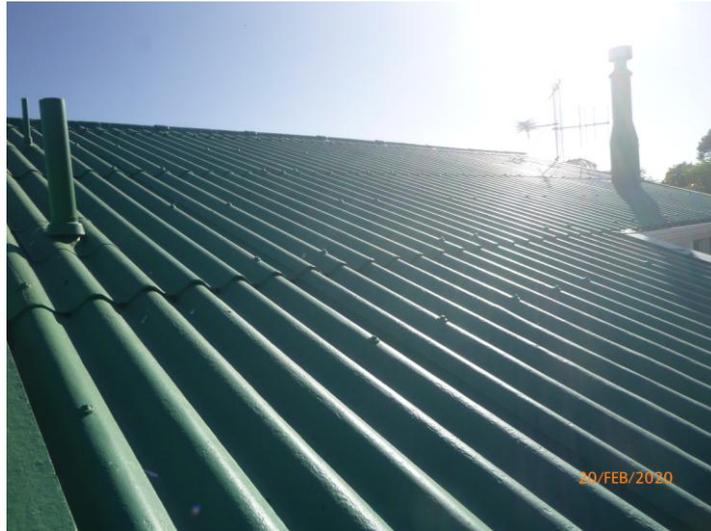
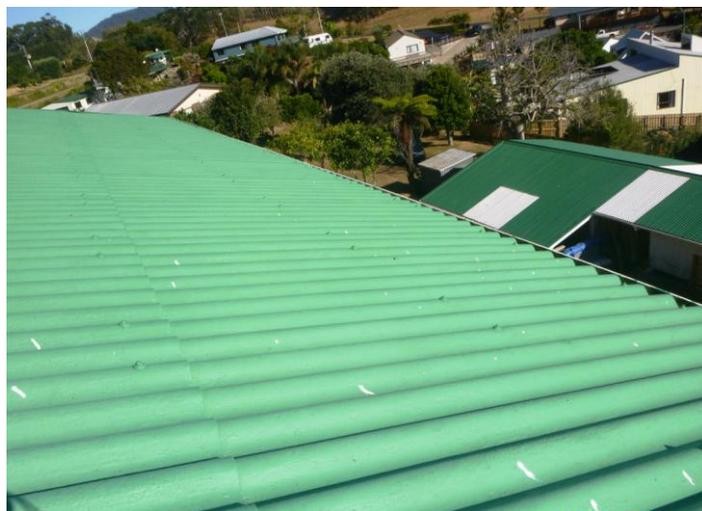
The roof installed to this dwelling is in good overall visual condition for its age

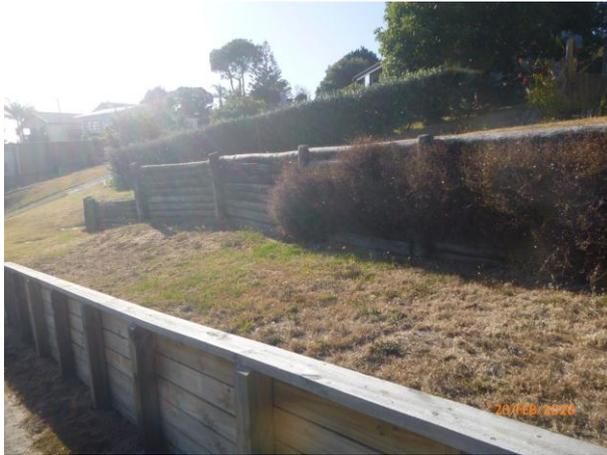
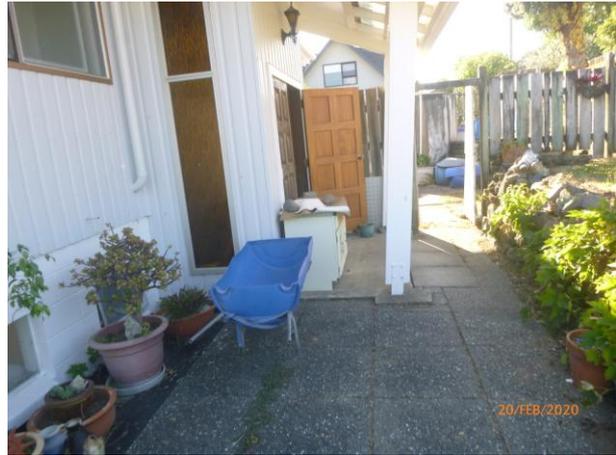
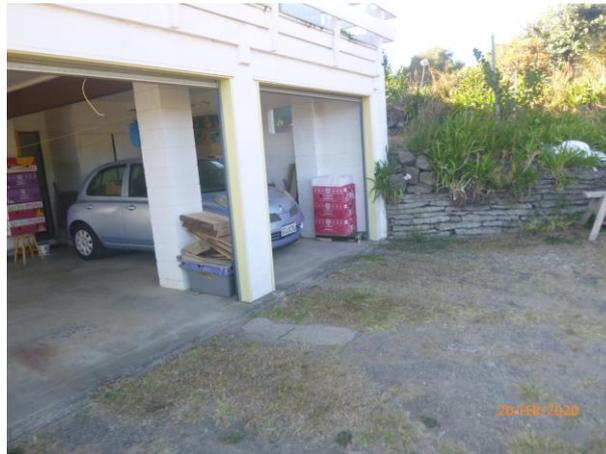
On the day of our inspection there were no signs of any excessive movement to these retaining walls

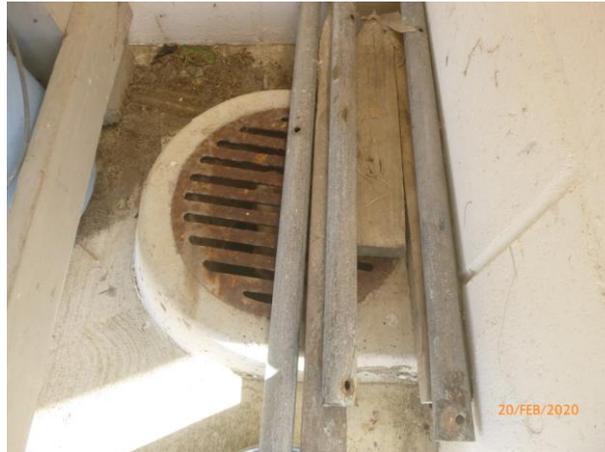
The gully trap has also been installed at the correct height above the ground to prevent surface water entry

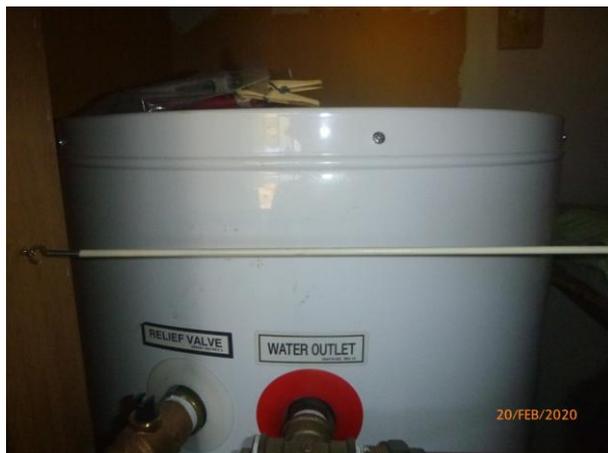
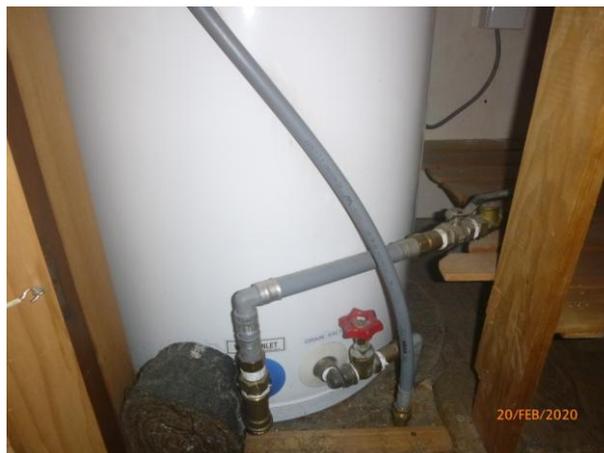
On the day of our inspection there were no leaks evident to this hot water cylinder and note that it is not seismically restrained as required

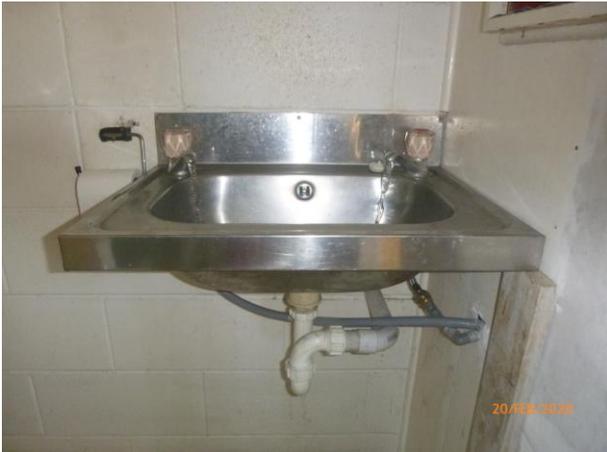
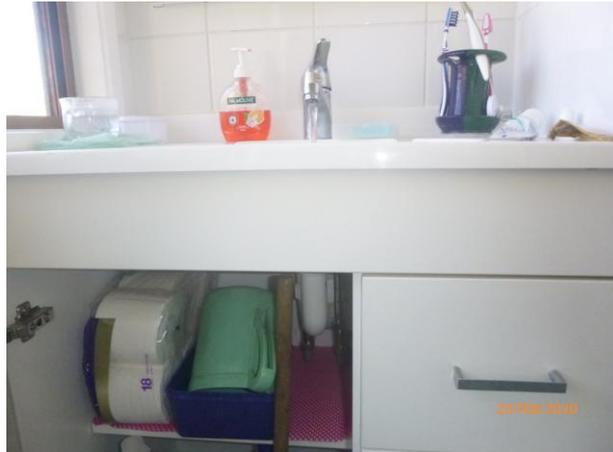
On the day of our inspection there were no leaks evident to the vanity unit or below the basin

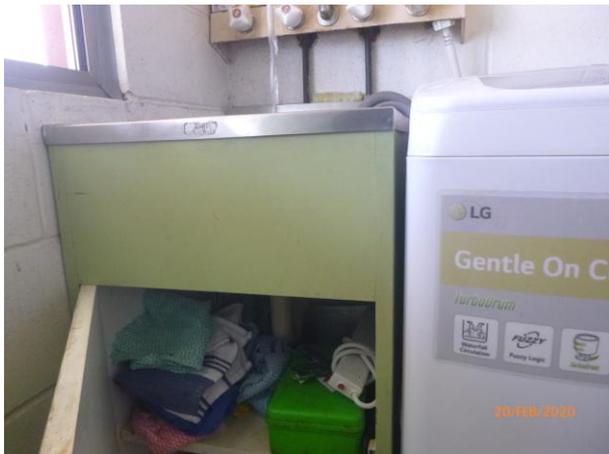
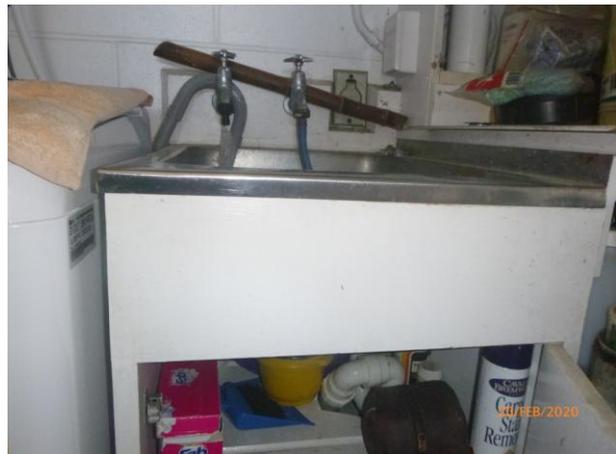
On the day of our inspection there were no leaks evident to the laundry tubs

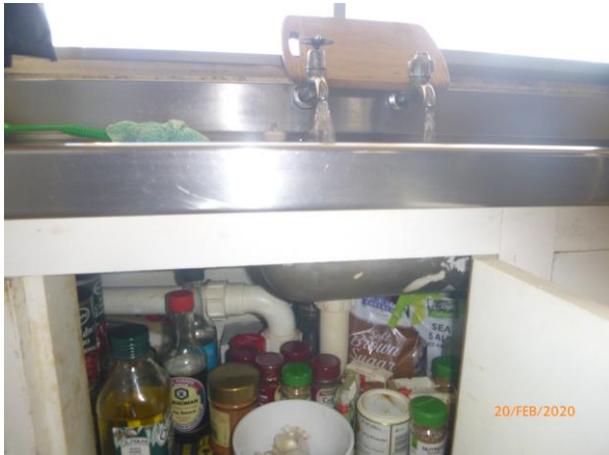
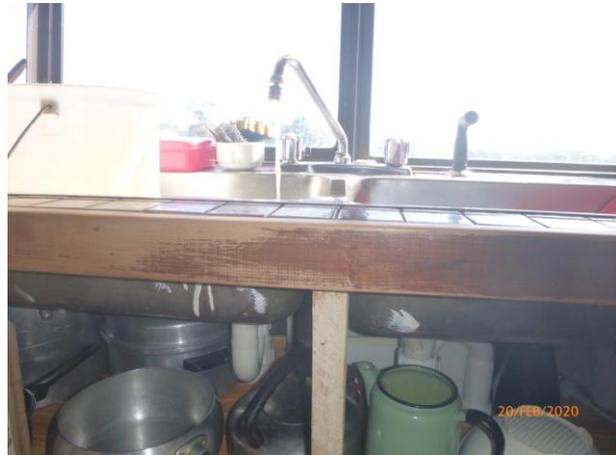
On the day of our inspection there were no leaks evident to the kitchen sink inserts
