KIWI HOUSE INSPECTIONS

Independent building inspection report on
4 Hansen Place, Katikati.

INDEPENDENT BUILDING INSPECTION
4 Hansen Place, Katikati

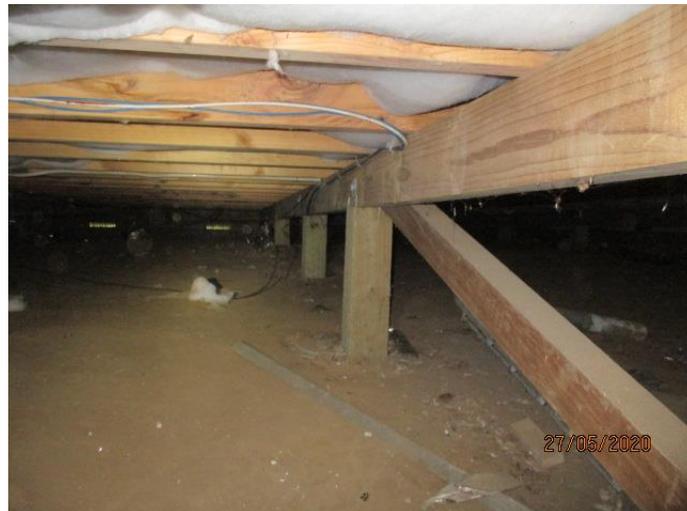
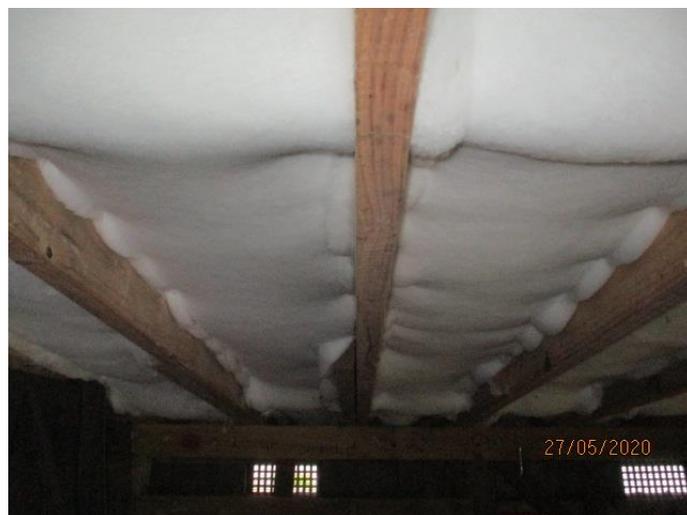
Underfloor insulation has been installed and is in good condition.

Subfloor insulation.

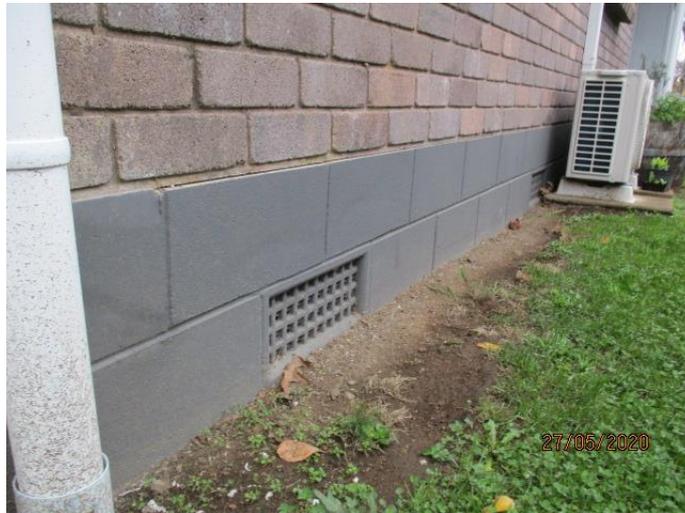
The current exterior finished ground levels are satisfactory to prevent any moisture ingress by means of capillary action. There is adequate height separation between the exterior finished ground levels and internal finished floor levels.

Example of good ground clearances.

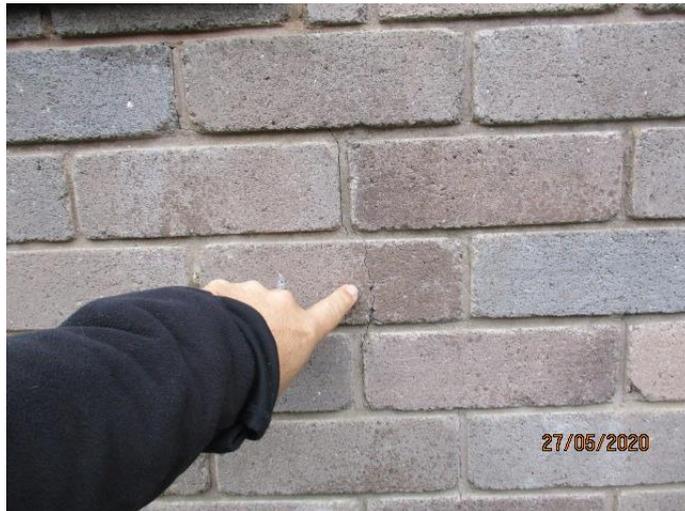
- A section of the brick veneer above and below the meter box has minor cracking visible. The cracking is not a structural issue as the brick cladding is a veneer only and no moisture ingress appears to have occurred through the cracks.
- A timber skirting trim fitted to the cladding at the front corner of the dwelling has deteriorated and may require removing or replacing. The deterioration was likely caused by moisture collecting on the top edge of the skirting over time.

Cracking in the brick veneer below the meter box.

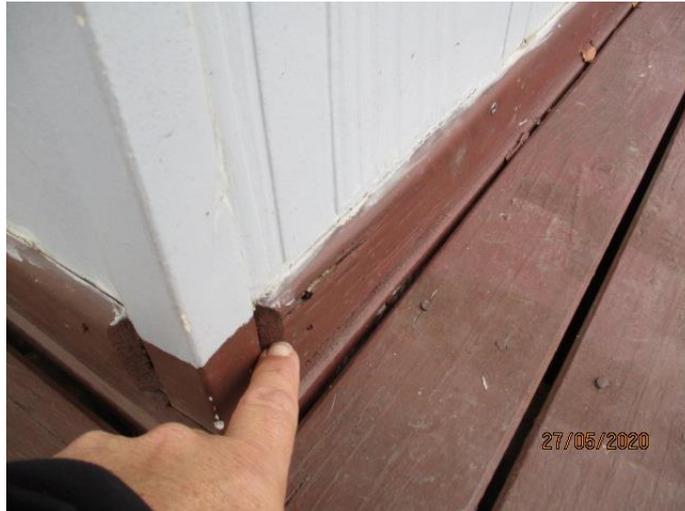
Deteriorated timber skirting trim at the front verandah.

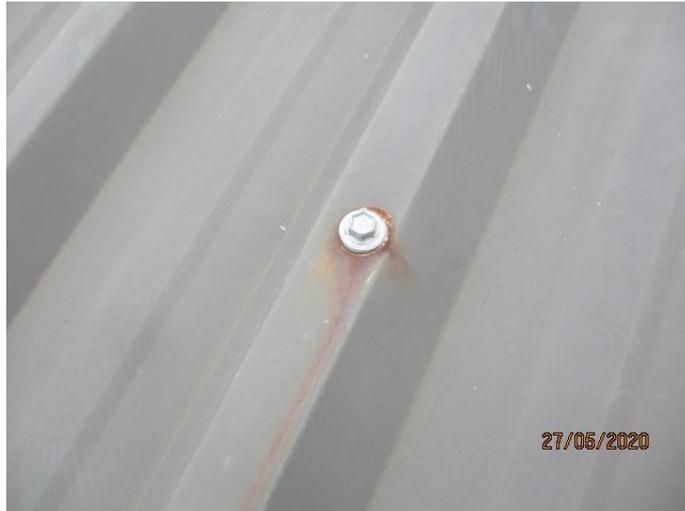
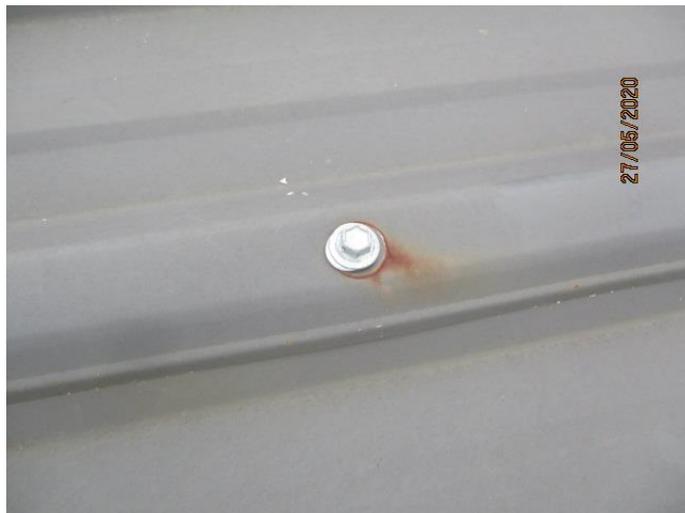
- Rust stains and surface rust are visible on the roof sheets around the roof screws. The rust may have been caused by rusted roof nails which have since been upgraded to roof screws. We recommend painting the entire roof to prevent the rust spreading.

Example of rust beneath the screw heads.

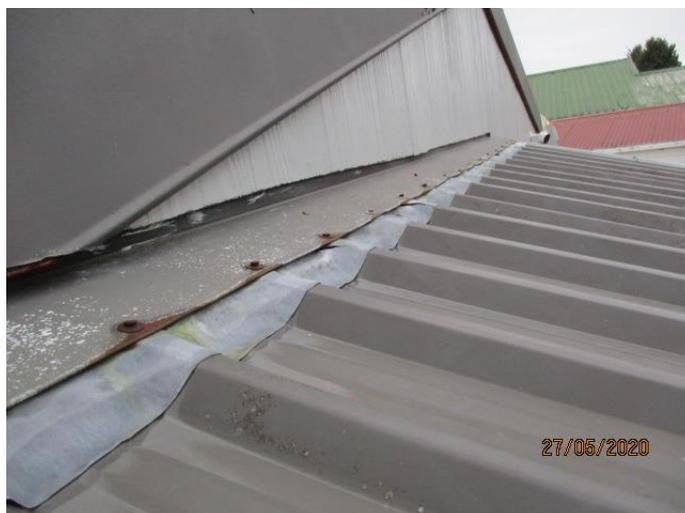
- The apron flashing along the verandah roof has rust forming along the front edge and the roof nails in the flashing have rusted. We recommend replacing the nails with screws before rust treating the affected areas and painting.

Rust on the apron flashing and nails.

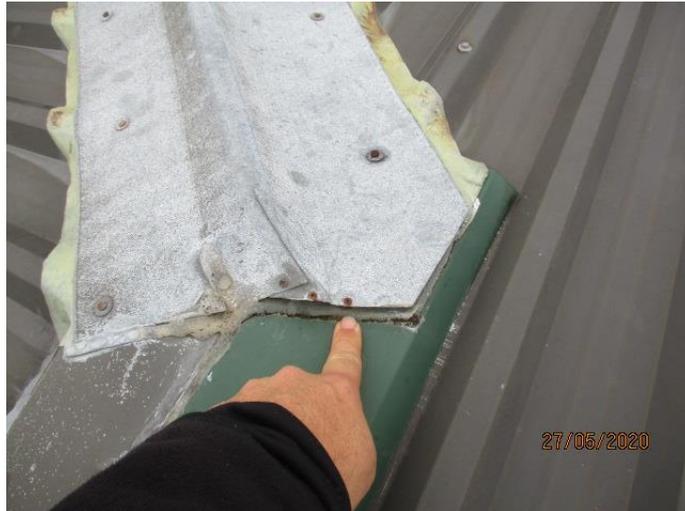
Hip flashing requires re-sealing to the barge flashing.

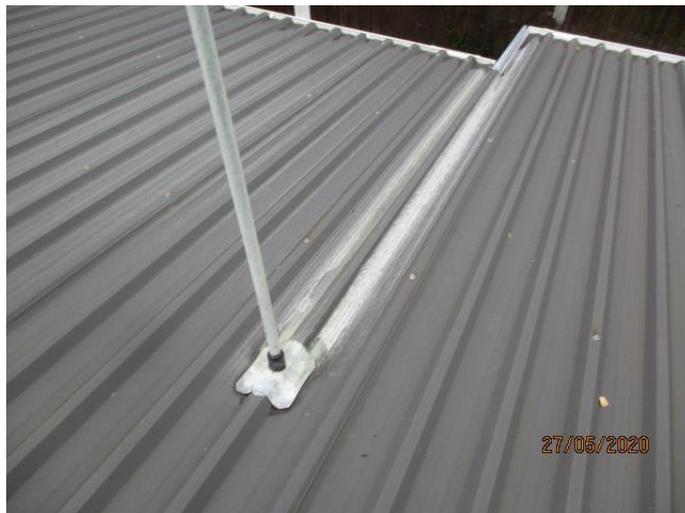
Corrosive deposits on the roof sheet below the vent pipe.

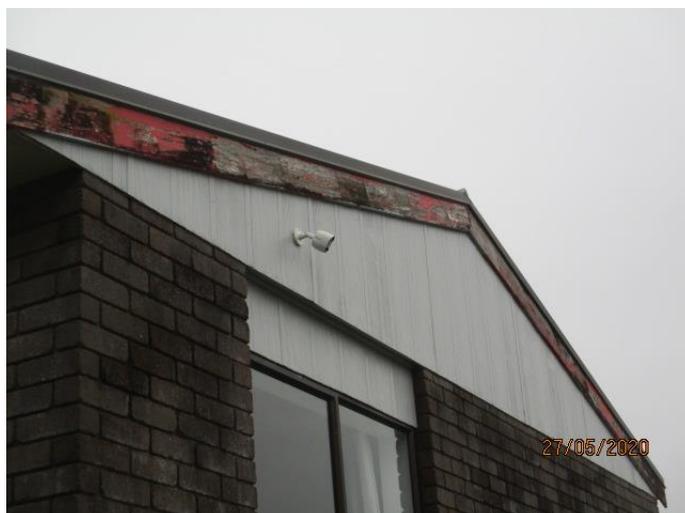
- The timber bargeboards at the rear of the dwelling have deteriorated due to a damaged paint finish. These two bargeboards may require replacing. The inspector was notified by the vendor that replacement bargeboards are on-site and are ready to install.

Deteriorated bargeboards.

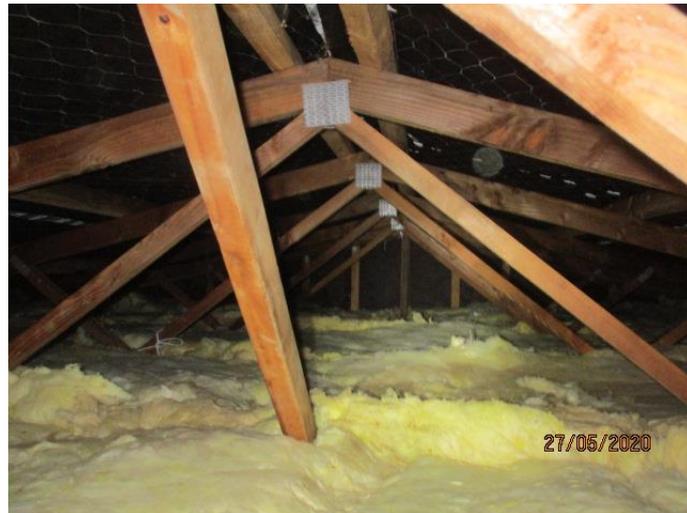
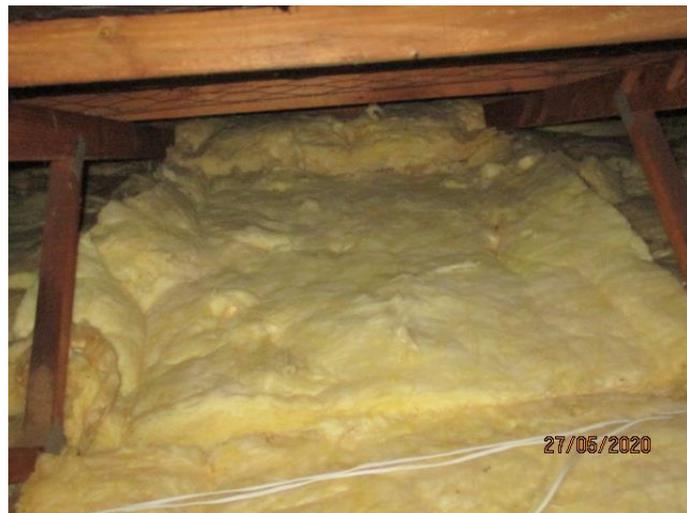
The roof cavity has been insulated with glass batt type blanket insulation which appears to be in good condition.

Ceiling insulation.

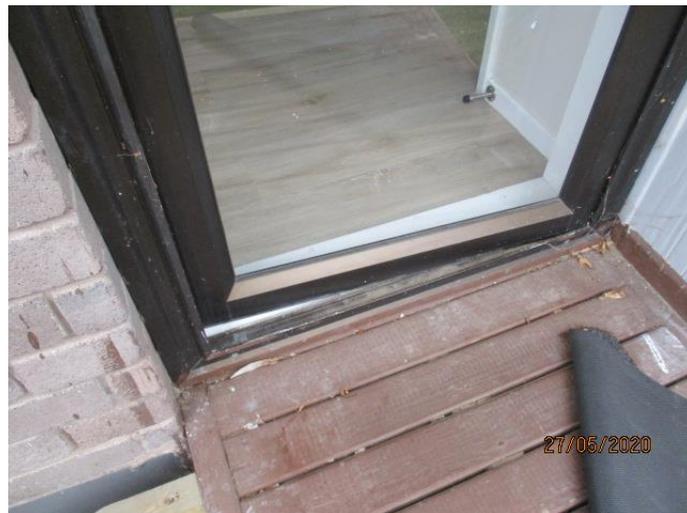
- The rear entrance/laundry door rubs on the sill when opening and closing and the door requires adjusting. Rain water may also be leaking over the bottom frame of the door and onto the timber sill – see the Moisture Readings section below for more detail.
- The kitchen window is missing a latch wedge plate and the window sash has some unwanted movement. Wedge plates are designed to keep the window sashes tensioned against the window frames when closed to prevent draughts and moisture ingress. Adhesive backed wedge plates can be purchased from most hardware stores.

Laundry door rubs on the door sill.

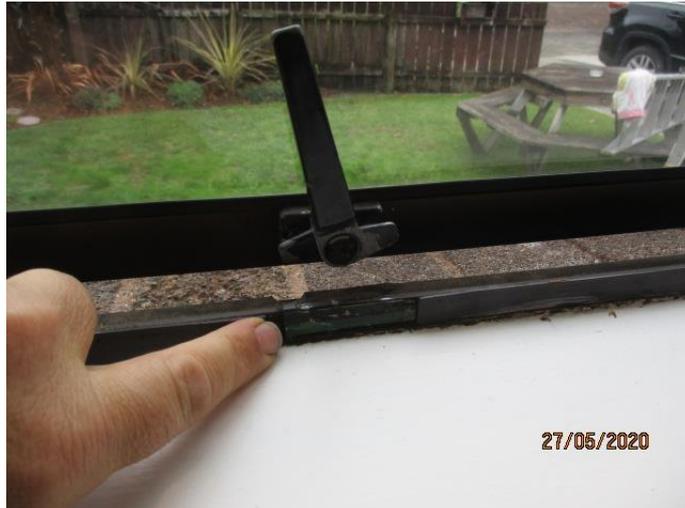
The kitchen window requires a latch wedge plate to hold the sash against the frame correctly.

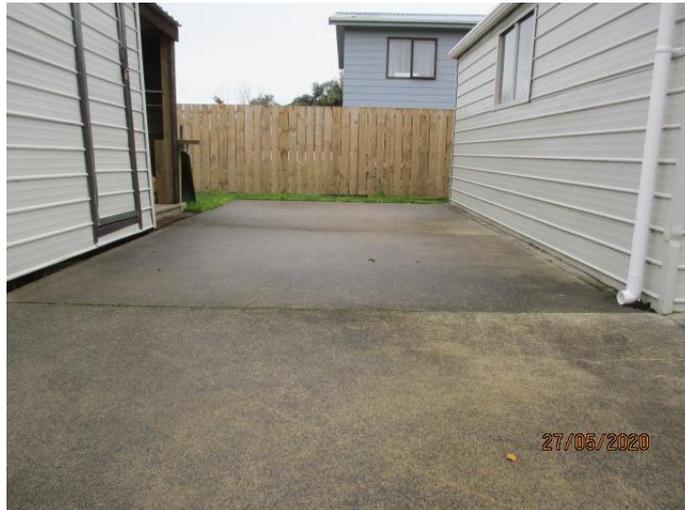
- The section of concrete parking at the side of the garage at the rear of the property does not appear have adequate fall and appears to direct surface water towards the side of the garage.

Section of concrete parking that appears to direct surface runoff towards the garage.

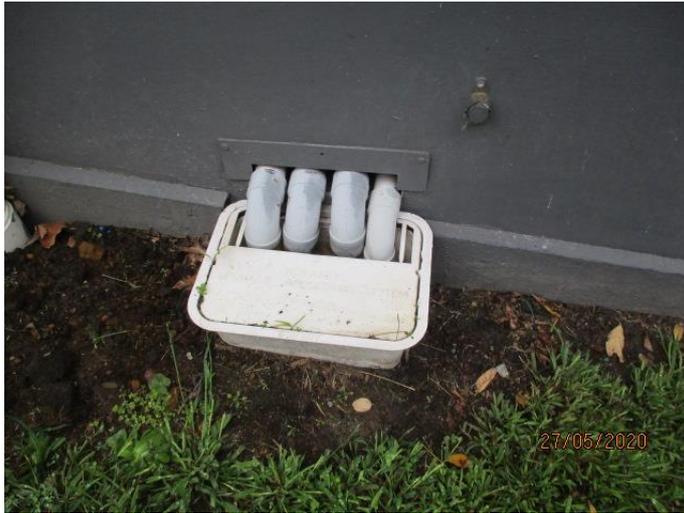
Correctly installed gully trap.

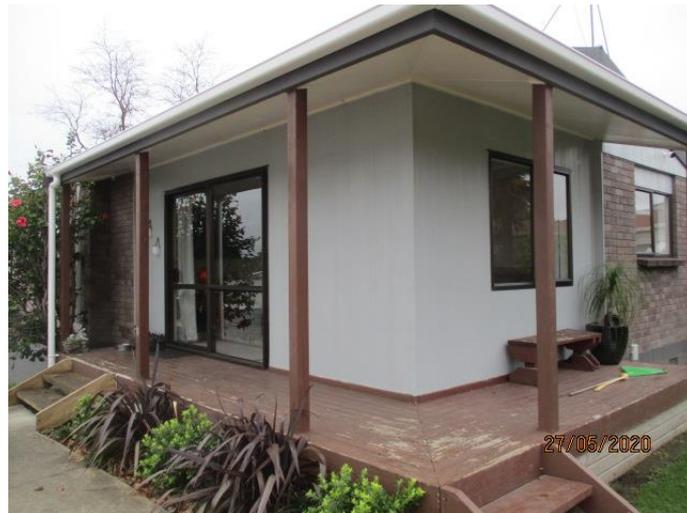
The covered (under the main roof) verandah at the front of the dwelling appears to have been well constructed using appropriate materials. Overall, the verandah is in reasonable condition for its type and age with only minor signs of wear and tear in the decks paint finish.

Front verandah.

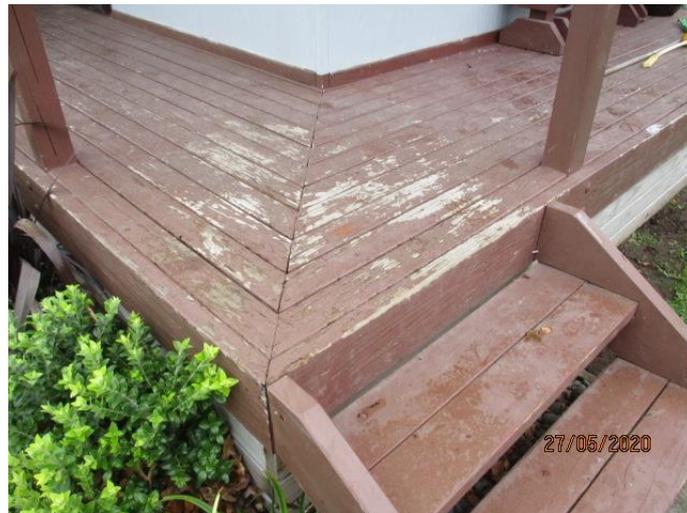
Minor wear and tear.

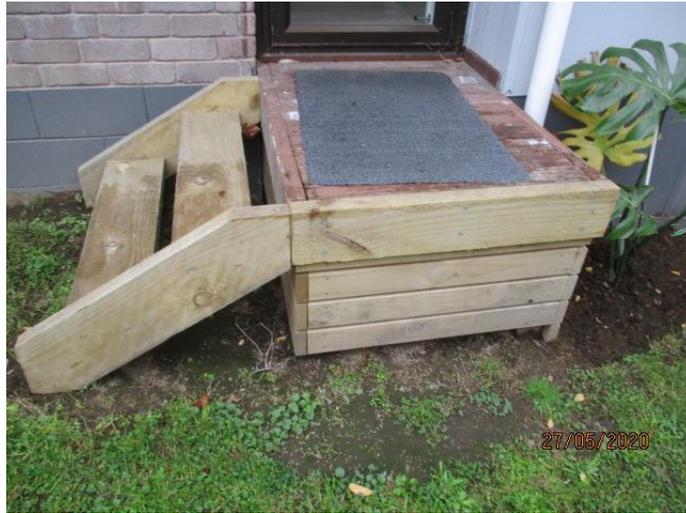
The timber landing off the rear entrance is in reasonable condition with no outstanding maintenance required at the time of inspection.

Rear landing.

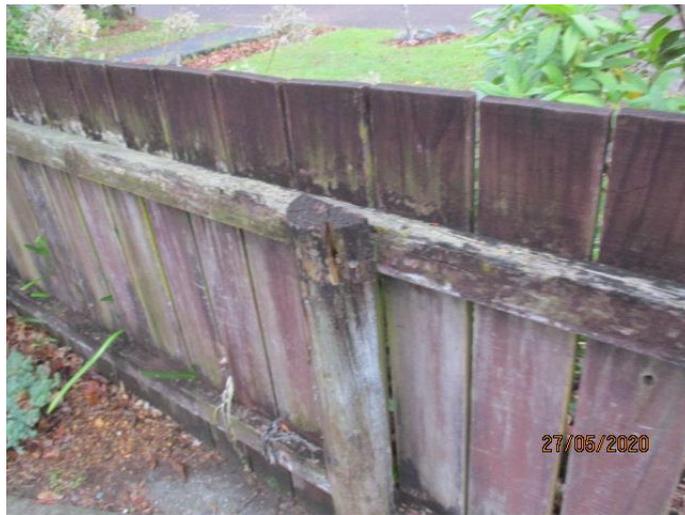
Fencing consists of timber posts and palings to the side boundaries with a mix of ribbed metal sheets and horizontal timber boards at the rear boundary. Overall, the fencing is sturdy and in reasonable condition with only minor signs of weathering/deterioration on the fence palings on the southeast corner of the property.

Example of minor weathering/deterioration on the front boundary fence.

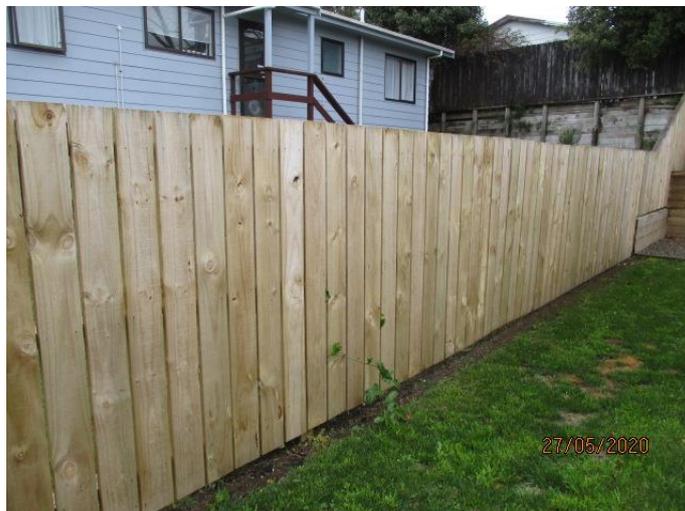
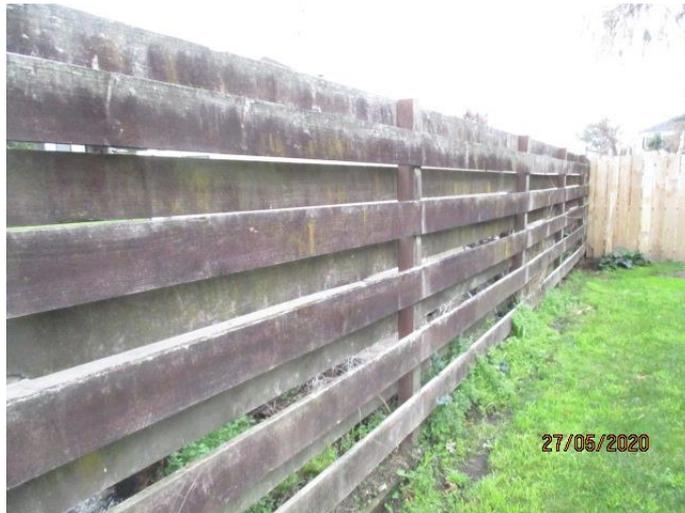
Fencing is in reasonable condition overall.

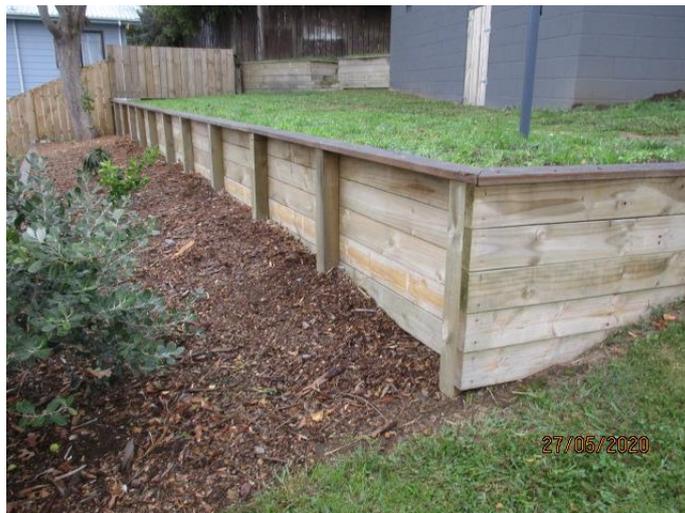
The timber post and board retaining walls have been well-built and are in good condition. There was no visible signs of deterioration or vertical/horizontal movement detected in the retaining at the time of inspection.

Retaining is in good condition.

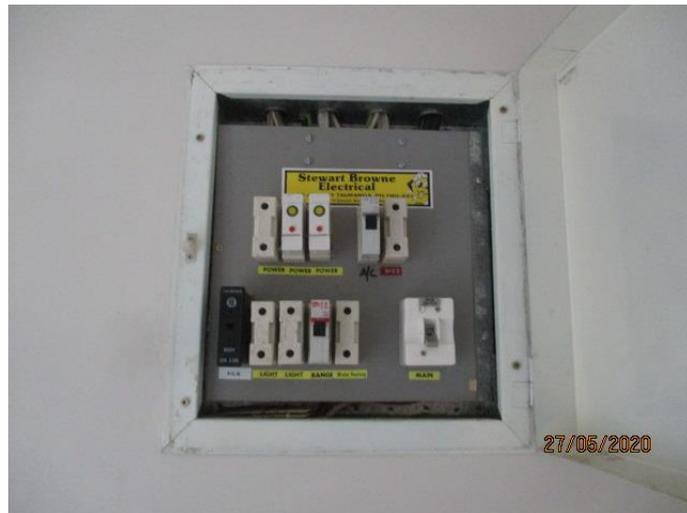
A standard distribution board has been professionally installed to the interior of the dwelling with no signs of excess heat build-up at either board or power points.

Distribution board.

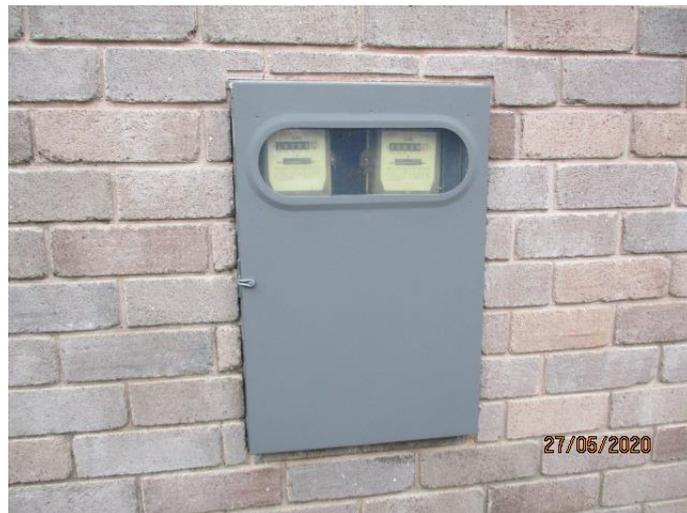
A standard meter board has been professionally installed to the exterior of the dwelling and appears to be adequately sealed to the cladding and is in good condition for its type and age.

Meter box.

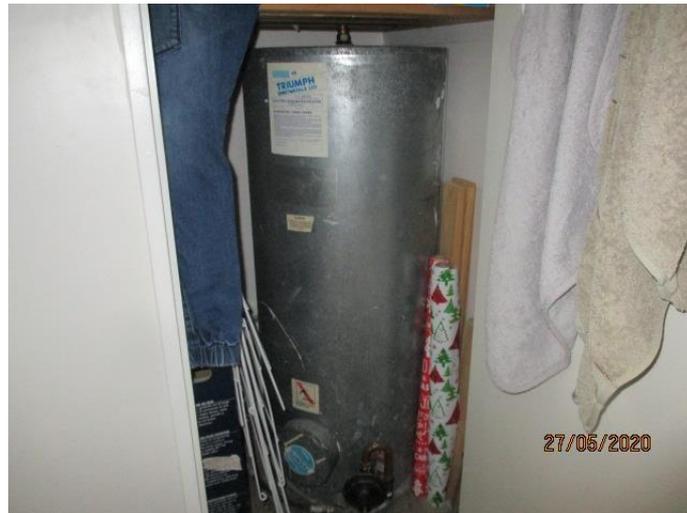
A 180-litre Triumph low pressure hot water cylinder (HWC) has been installed in a hallway cupboard. The hot water system appears to have been professionally installed and is in reasonable condition with the correct fittings and valves installed. The HWC was operating correctly at the time of inspection.

HWC.

We recommend fitting seismic restraints to the hot water cylinder to prevent potential movement during an earthquake.

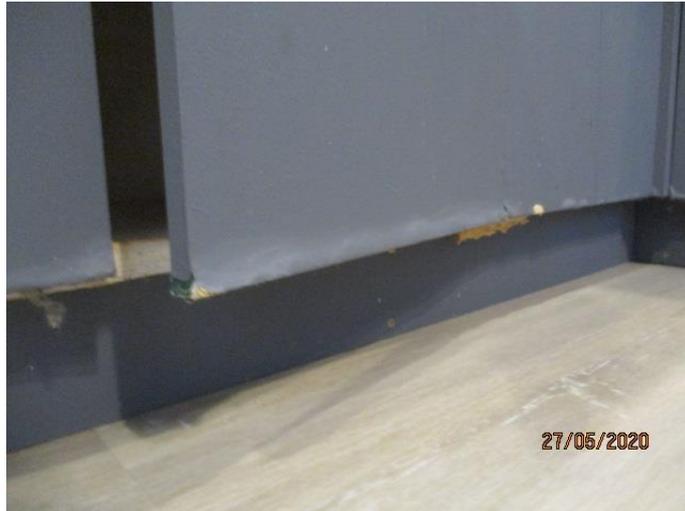
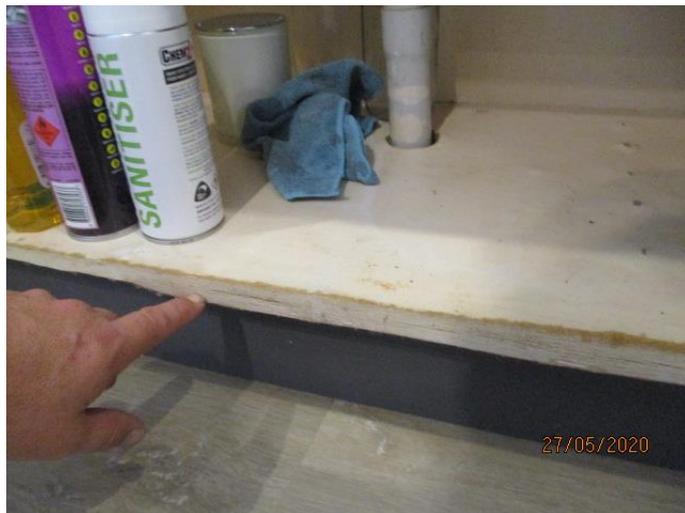
- The cupboard doors and shelves below the kitchen sink have swollen due to being exposed to excess moisture. The damage was likely caused by a past fault in the under-sink plumbing which has since been resolved. The cupboards were dry at the time of inspection.
- The bottom drawer in the kitchen has a broken handle.

Swollen kitchen cupboards.

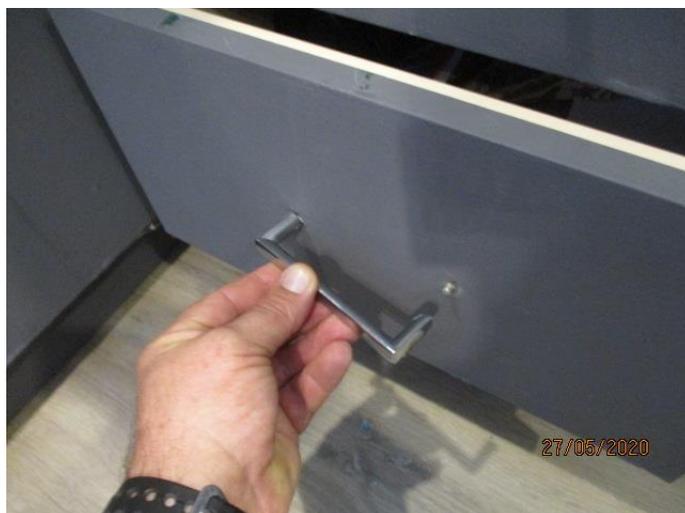
Broken drawer handle.

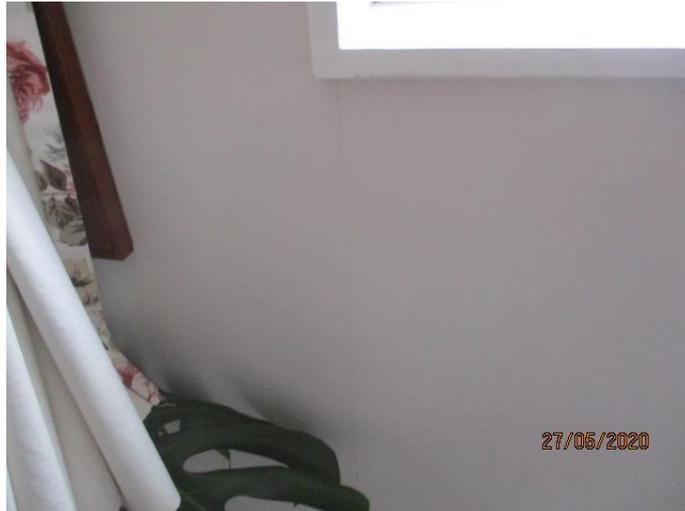
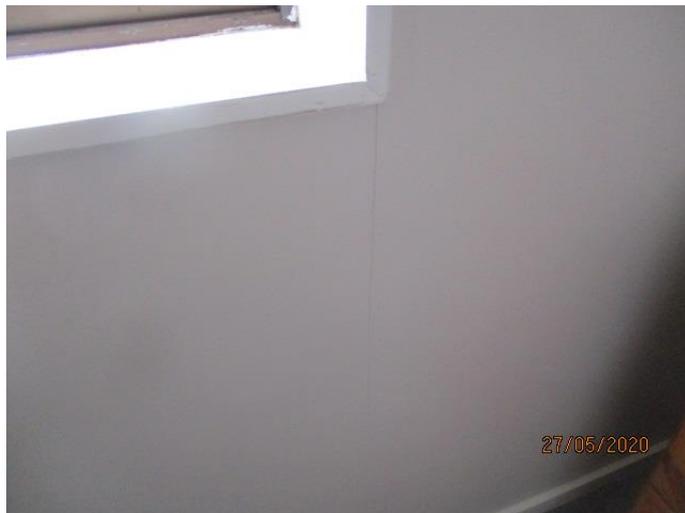
The plasterboard wall and ceiling linings have been stopped and finished to a good standard and are in reasonably good condition with only minor cracking at the plastered wall lining joints below some windows. The cracks are non-structural and are due to the natural movement in the dwelling over time.

Minor wall lining crack.

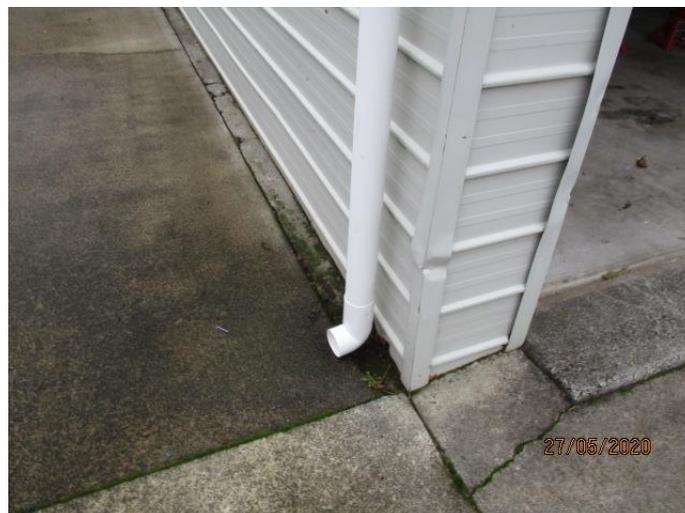
Garage downpipe requires connecting to the stormwater system.

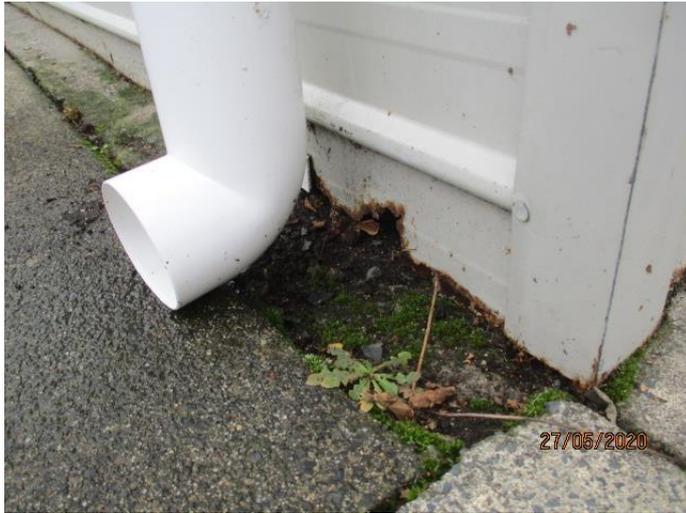
- The bottom edge of the metal wall cladding on the north elevation of the garage has rusted and this is likely caused by surface runoff being directed against this wall by the concreted parking area as mentioned in the Plumbing and Drainage section above. It may be prudent to paint the lower part of the affected cladding with a paint on type membrane to prolong the claddings lifespan.
- The downpipe on the northwest corner of the garage drains onto the driveway and this may be contributing to the deterioration visible in the cladding in this area. We recommend connecting this downpipe to the stormwater system.

Rusted garage cladding.

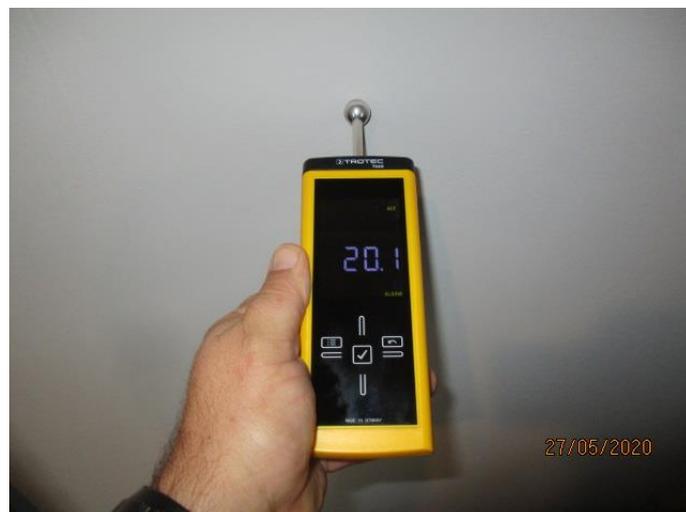
A base reading was taken on an internal wall in the lounge, which is known to be dry, giving a reading of 20.1. All readings returned figures of between 22 and 51 indicating there was no excess moisture present in the internal framing in the areas tested at the time of inspection, with the exception of the area to note below.

Base reading of 20.1.

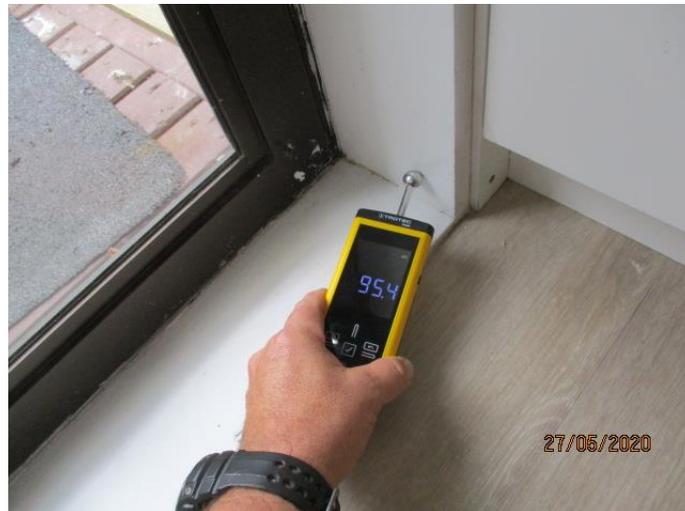
- Elevated moisture readings of up to 95.4 were obtained at the rear entrance/laundry door jamb. The elevated readings indicate that the door jamb and wall framing in this area are possibly damp and this may be due to the moisture leaking over the door sill during periods of heavy rain being absorbed by the door jamb. We recommend improving the door sills draining system.

Elevated reading of 95.4.

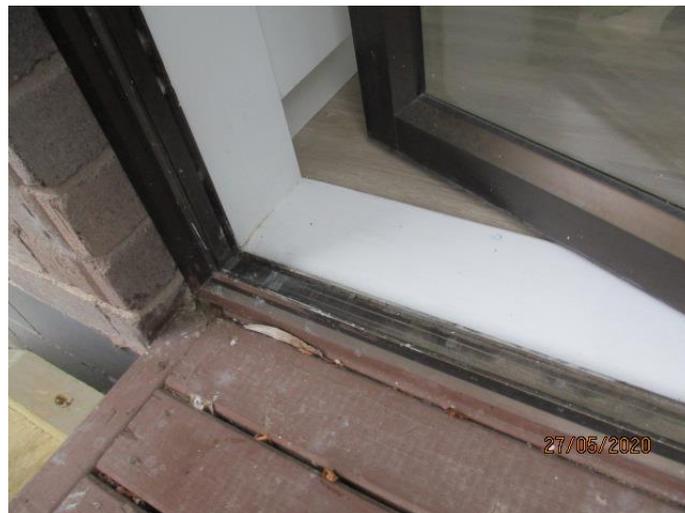
Moisture may be leaking over the aluminium door sill during heavy rains.
