KIWI HOUSE INSPECTIONS

Independent building inspection report on
5 Grosvenor Place, Katikati

INDEPENDENT BUILDING INSPECTION
5 Grosvenor Place, Katikati

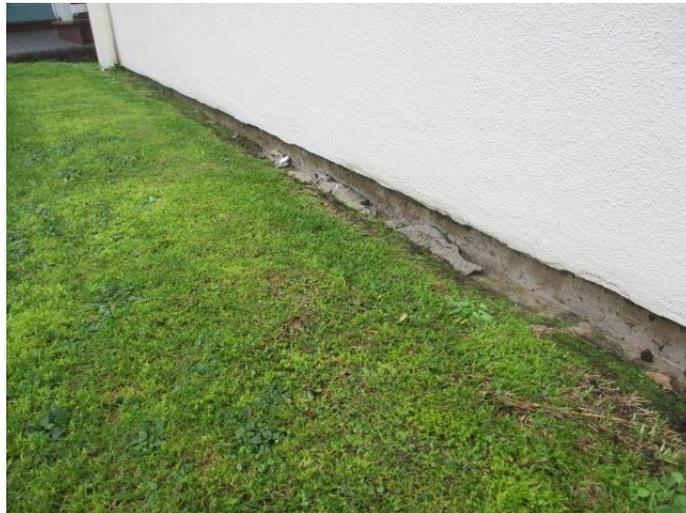
The current exterior finished ground levels are satisfactory to prevent any moisture ingress by means of capillary action. There is adequate height separation between the exterior finished ground levels and internal finished floor levels.

Example of adequate ground clearances.

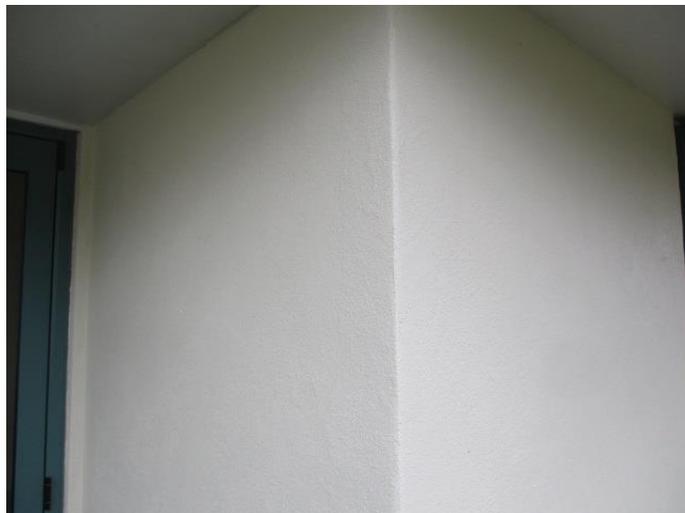
The cladding is in good condition overall with no signs of cracking or movement in the textured plaster finish detected at the time of inspection. No outstanding cladding maintenance appeared to be require at the time of inspection.

The Insulclad type cladding is in good condition overall.

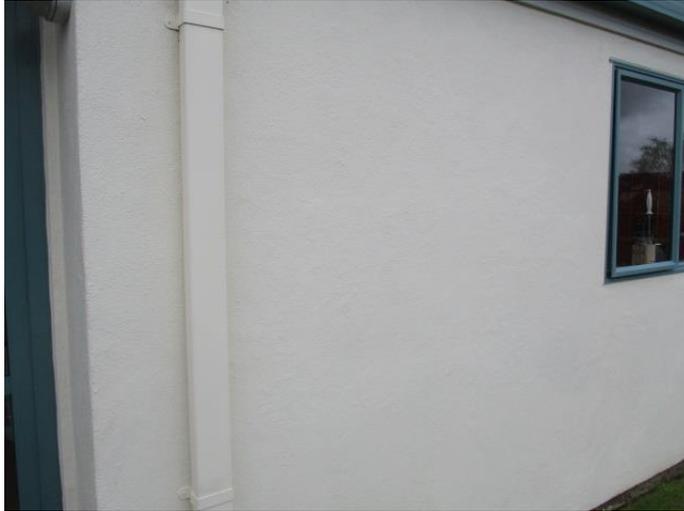
The Harditex type cladding is in good condition overall.

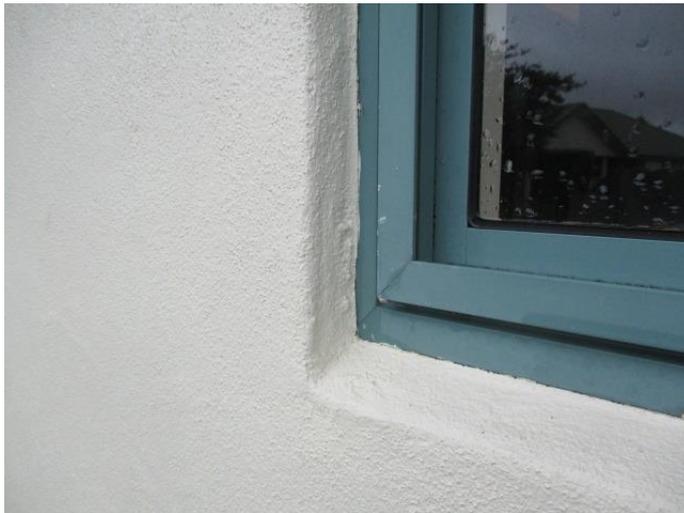
Example of good seals around cladding penetrations.

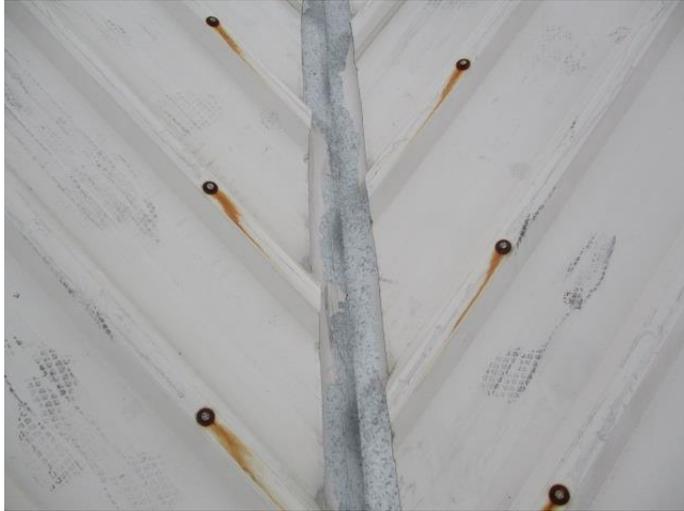
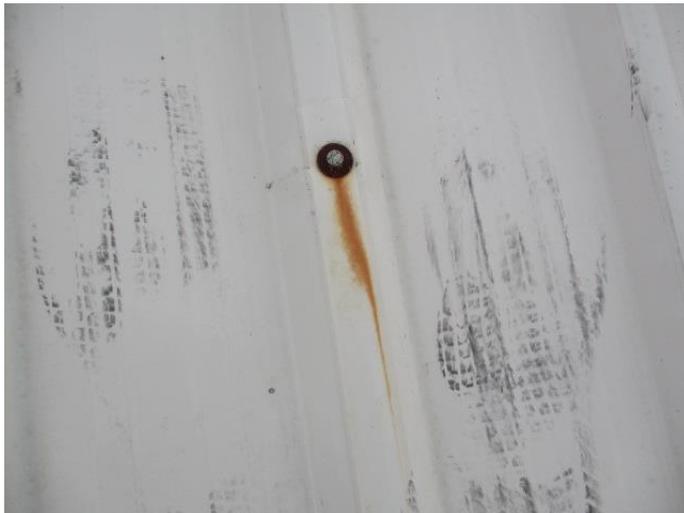
- The majority of the roof nails have rusted due to being in a coastal area and rust staining is visible on the roof sheets below the nails. We recommend replacing the roof nails with roofing screws and repainting the roof to prevent the rust stains causing premature deterioration.
- The roof sheets that drain onto the small Butynol roof over the front entrance have rusted where they overlap the lower roof. The deteriorated sheets require either patching or replacing to prevent the rust spreading. The rusted area of roof sheets is located over the lower roof and has not allowed roof runoff to leak into the roof cavity.

Example of rusted roof nails.

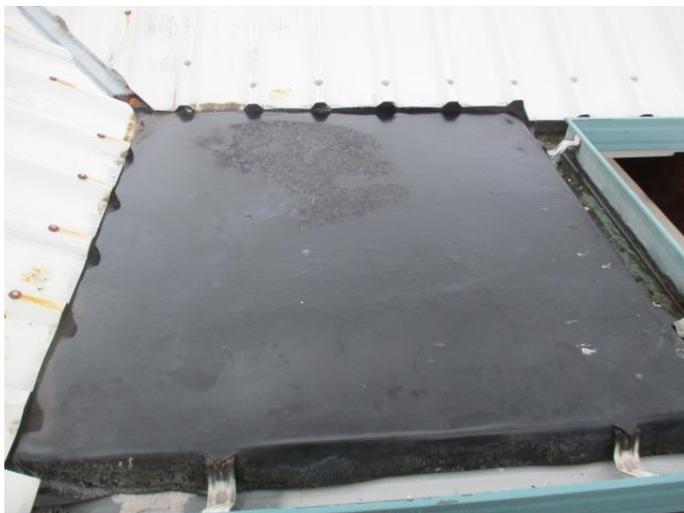
The small Butynol rubber membrane lined roof above the front entrance has been correctly laid with adequate waterproofing details installed.

Small Butynol roof above the front entrance.

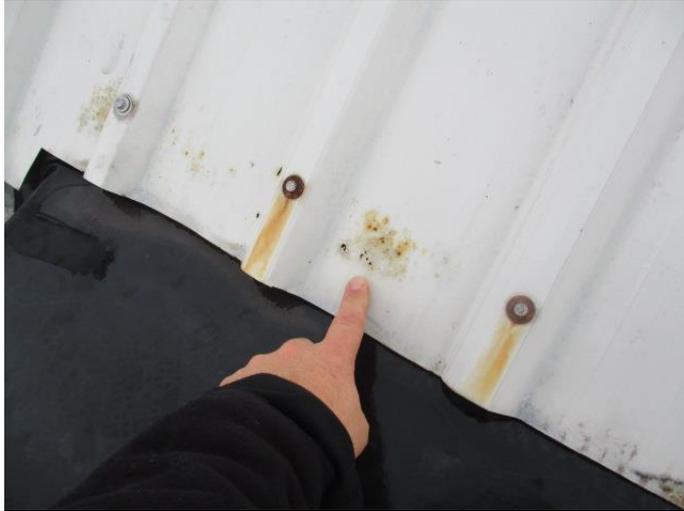
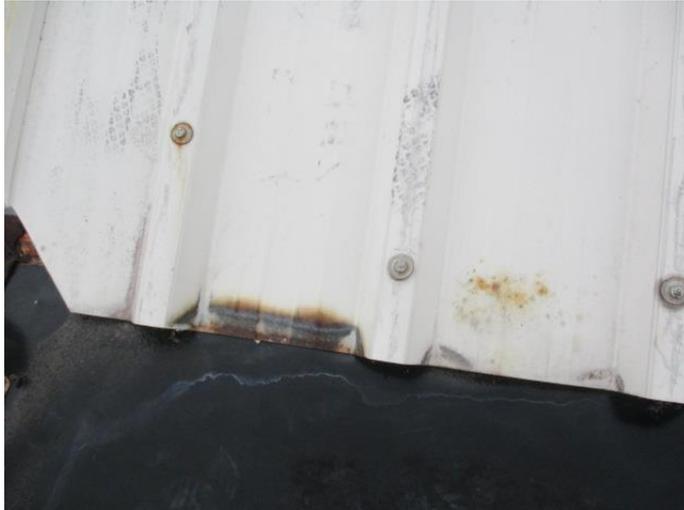
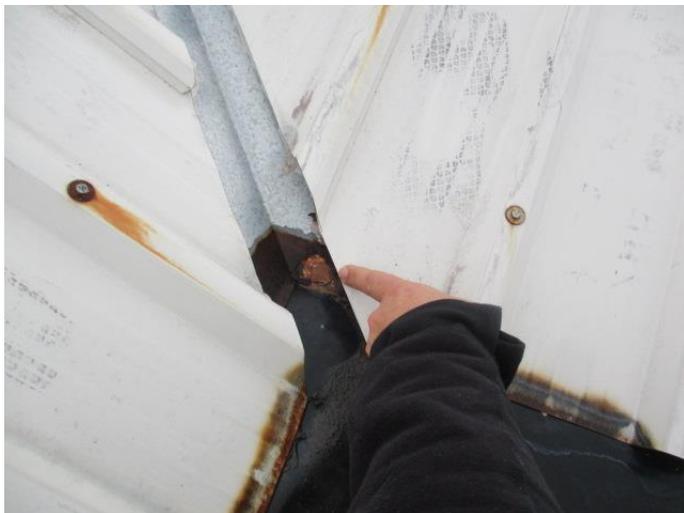
Example of roof sheet deterioration above the front entrance.

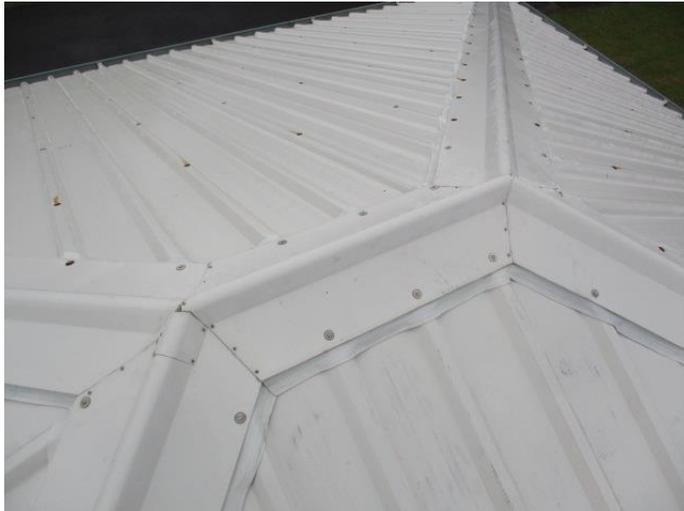
Example of neatly finished roof flashings.

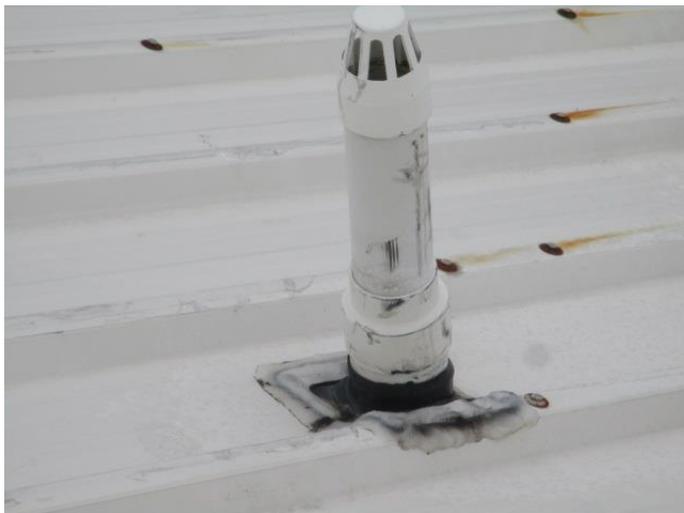
Roof penetrations, vent pipes, etc. are flashed and sealed appropriately.

Example of correctly flashed roof penetrations.

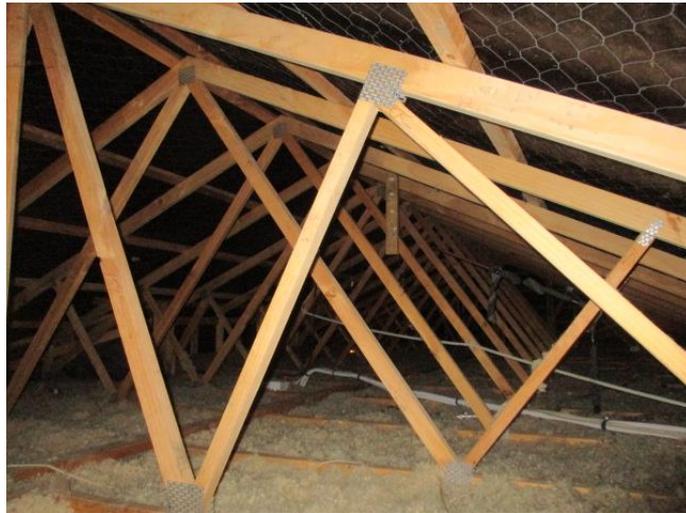
The roof has been built using conventional, specific design manufactured roof trusses in a hip/valley roof formation. The roof appears to have been well constructed and is in good condition for its type and age with no obvious signs of sagging or deterioration.

Roof construction.

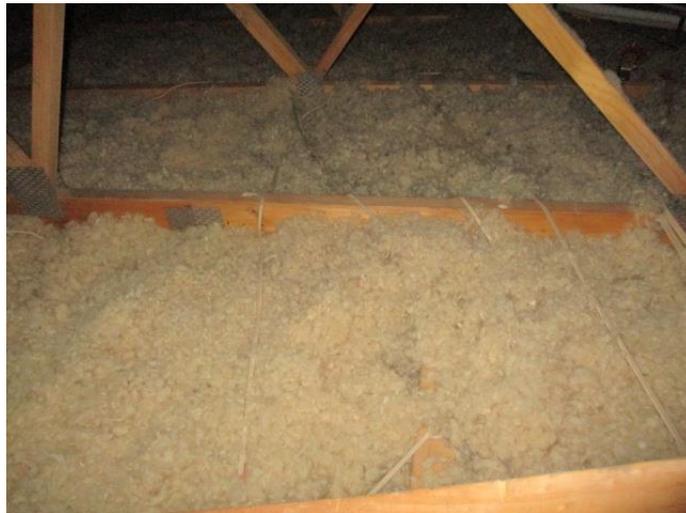
The roof cavity (with the exception of the garage) has been insulated with loose fill type insulation which appears to be in reasonable condition.

Roof insulation.

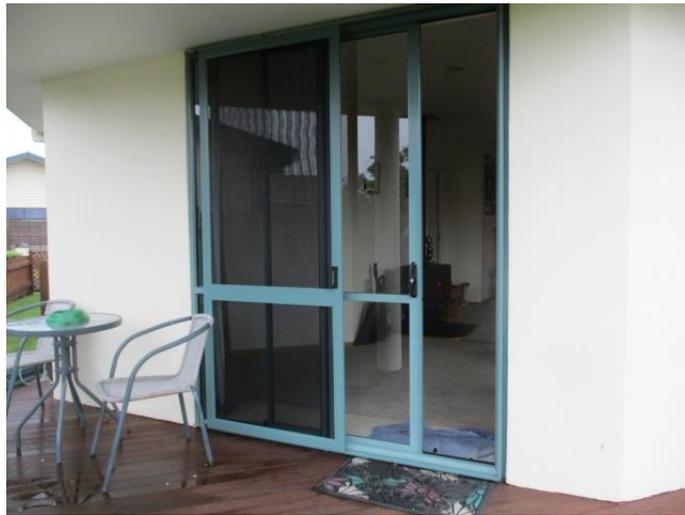
The joinery is in good condition overall.

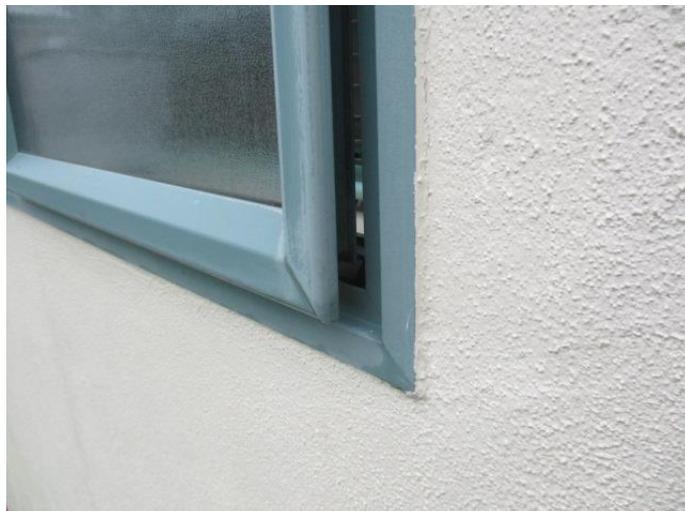
The joinery well sealed to the cladding.

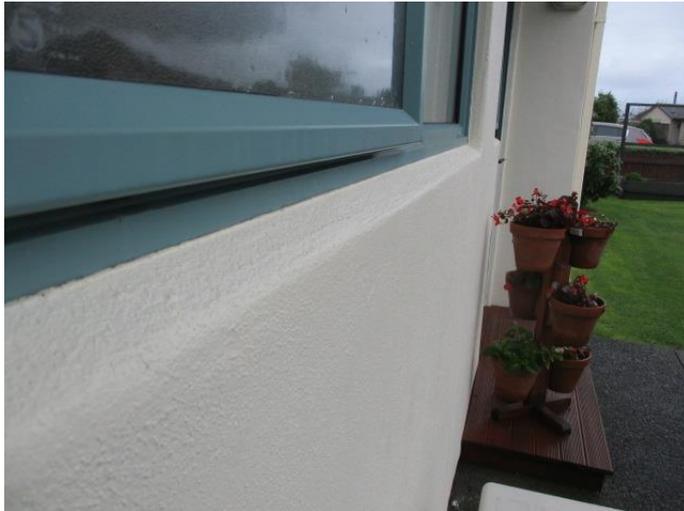
Sills have sufficient falls installed.

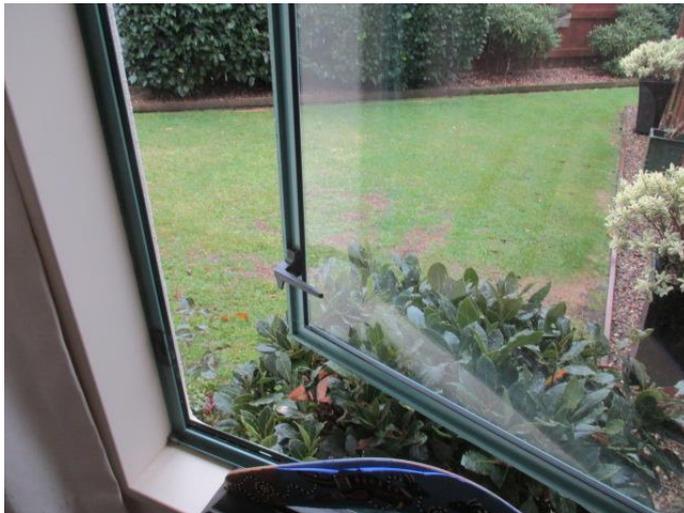
Windows and doors are operating correctly.

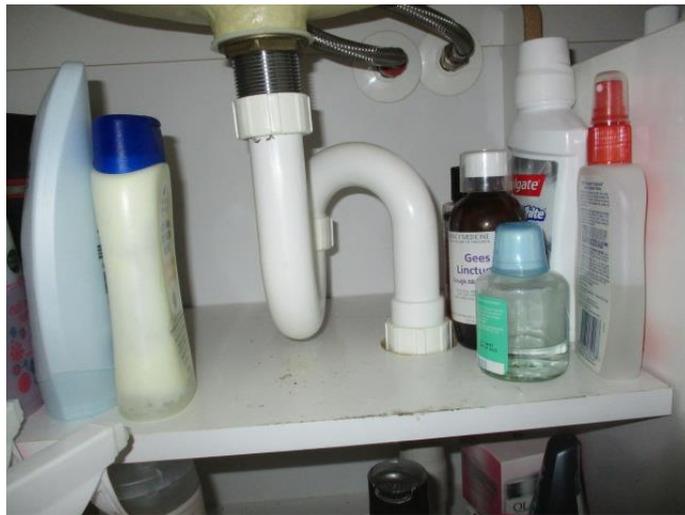
Example of correctly installed under sink plumbing.

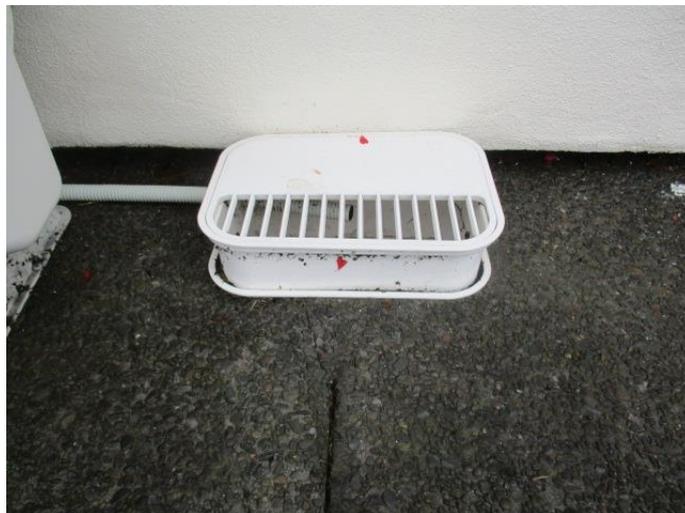
Example of correctly installed gully traps.

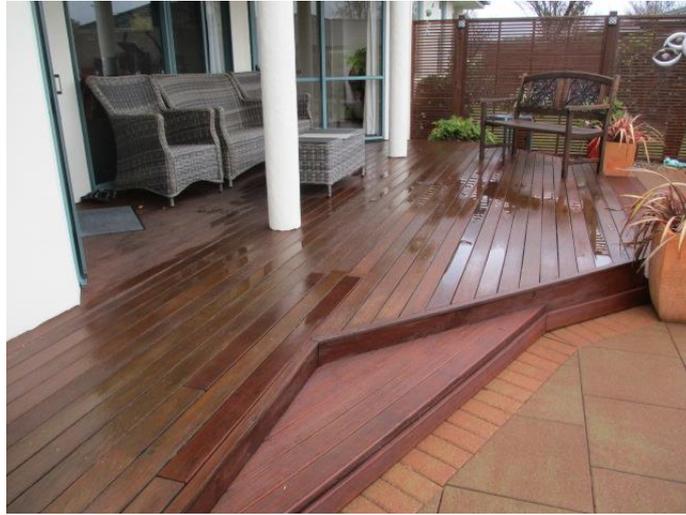
The timber deck along the north elevation of the dwelling has been well constructed using the correct materials. Overall, the deck is in good condition for its type and age with no outstanding maintenance required at the time of inspection.

Decking is in good condition.

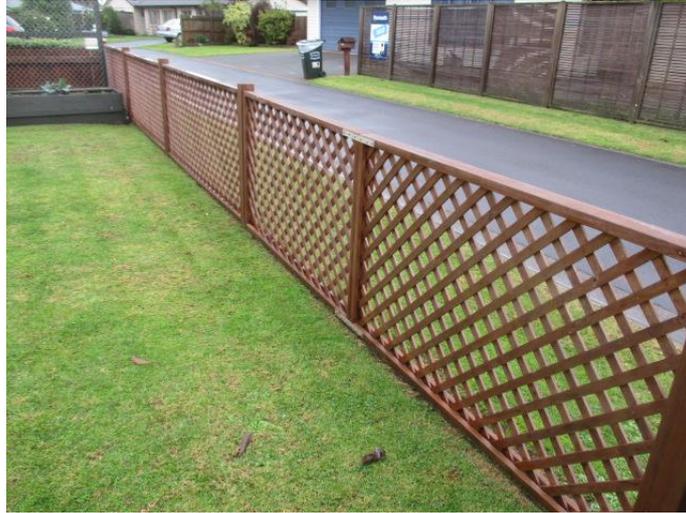
Lattice type fencing.

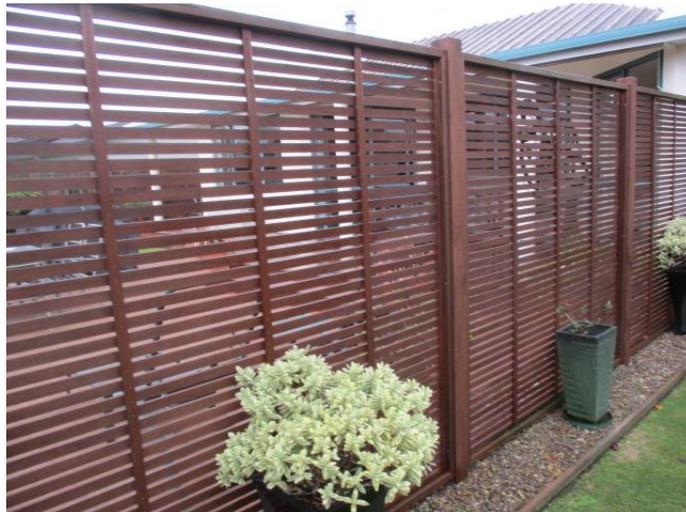
Horizontal batten screens.

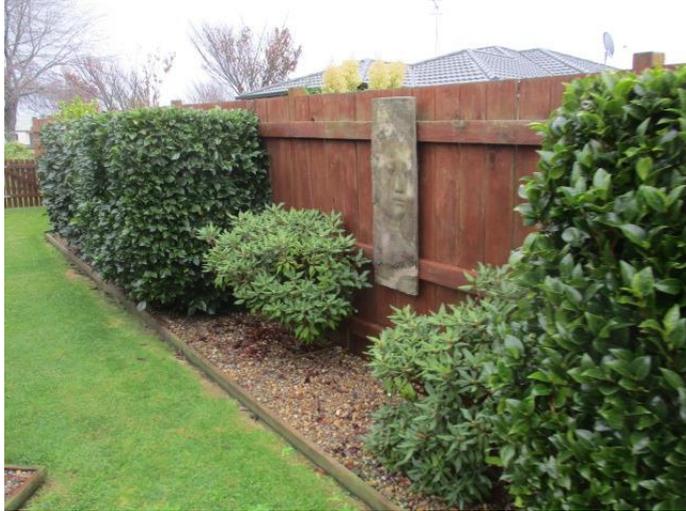
Overall, the fencing has been well installed, is sturdy and in good condition with the only area to note being a slight lean in a section of the post and paling fencing on the north boundary.

Post and paling fencing with slight lean.

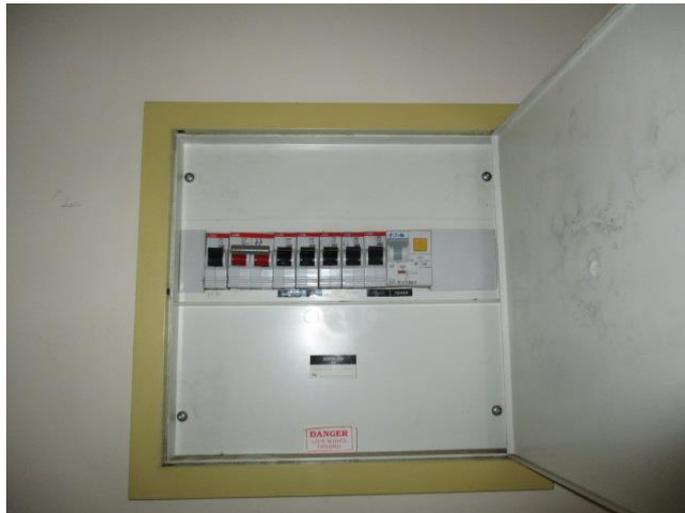
Distribution board.

A standard distribution board has been professionally installed to the interior of the dwelling with no signs of excess heat build-up at either board or power outlets.

The distribution board contains Residual Current Device (RCD) circuit breakers to comply with modern standards.

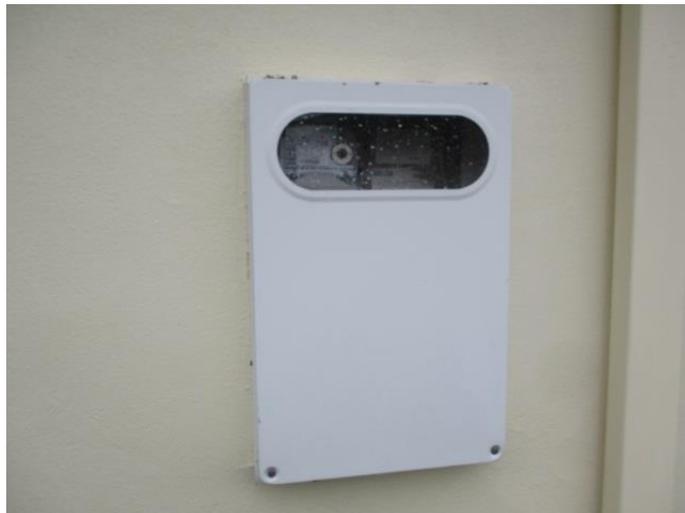
Meter box.

A standard meter box has been professionally installed to the exterior of the dwelling and appears to be well sealed to the cladding and in reasonably good condition for its type and age.

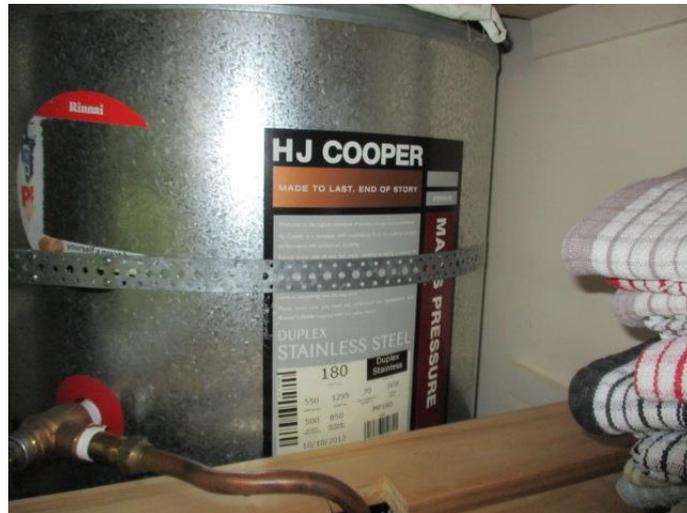
HWC.

A 180-litre HJ Cooper mains pressure hot water cylinder (HWC) has been installed at the back of a hallway cupboard. The hot water system appears to have been professionally installed and is in good condition with the correct fittings, valves and seismic restraints installed.

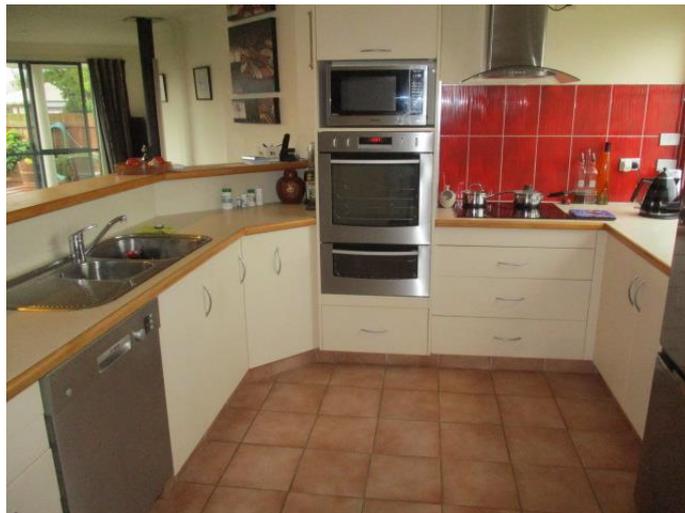
The kitchen bench tops, units and appliances are all in good condition for their type and age and there is a working exhaust fan installed above the cooktop.

Kitchen is in good condition.

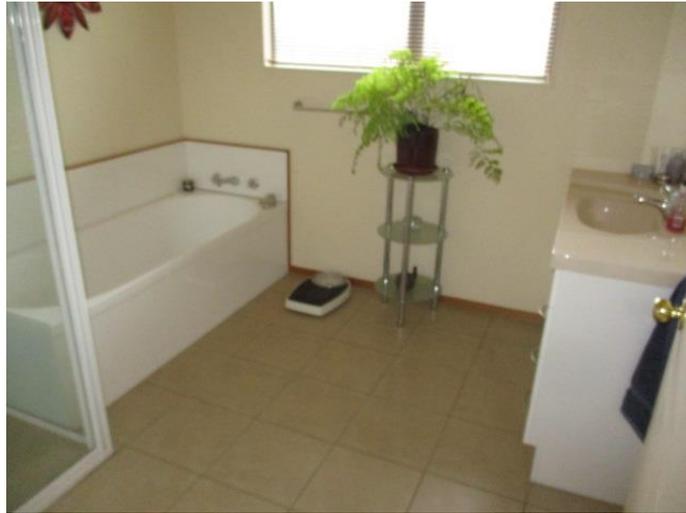
The bathrooms are in good condition overall.

Bathrooms are in good condition.

Although there was no signs of condensation/moisture damage visible in the bathrooms at the time of inspection, we recommend installing exhaust fans in both bathrooms to aid ventilation.

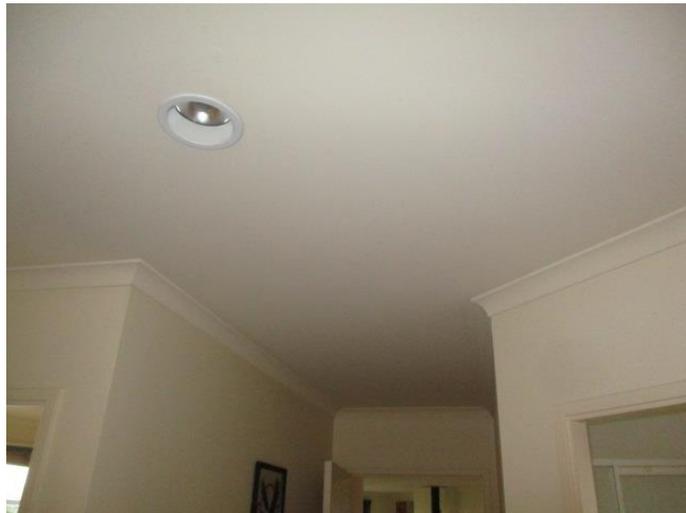
Ceilings are straight and true throughout the dwelling.

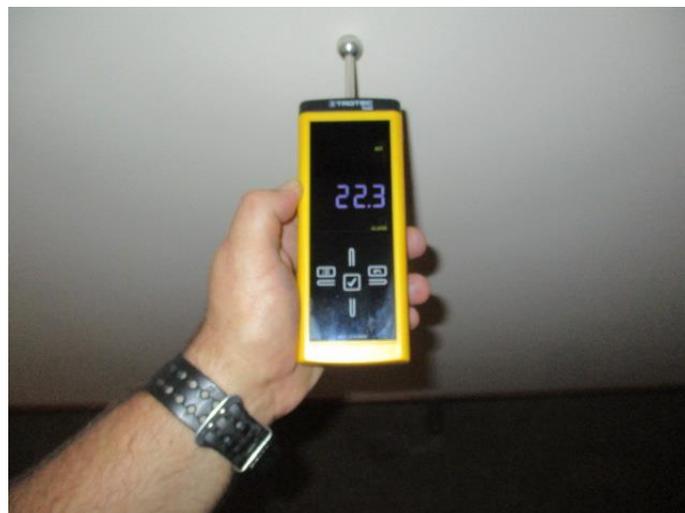
A base reading was taken on an internal wall in the foyer which is known to be dry giving a reading of 22.3. All readings returned figures of between 26 and 48 indicating there was no excess moisture present in the internal framing in the areas tested at the time of inspection.

Base reading of 22.3.
